CRS No. N05202

Name: House, Road 420

CULTURAL RESOURCE SURVEY
SURVEY UPDATE FORM

DELAWARE STATE HISTORIC PRESERVATION OFFICE
15 THE GREEN, DOVER, DE 19901

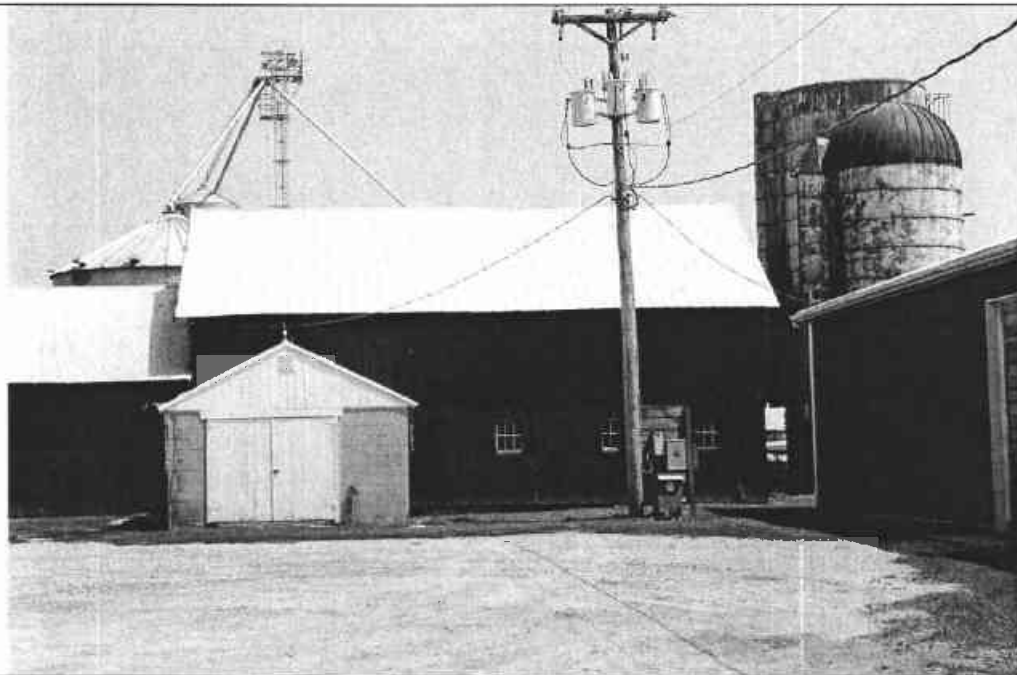
N05224. Photograph 4: Horse barn/dairy barn and milk house, view looking east.

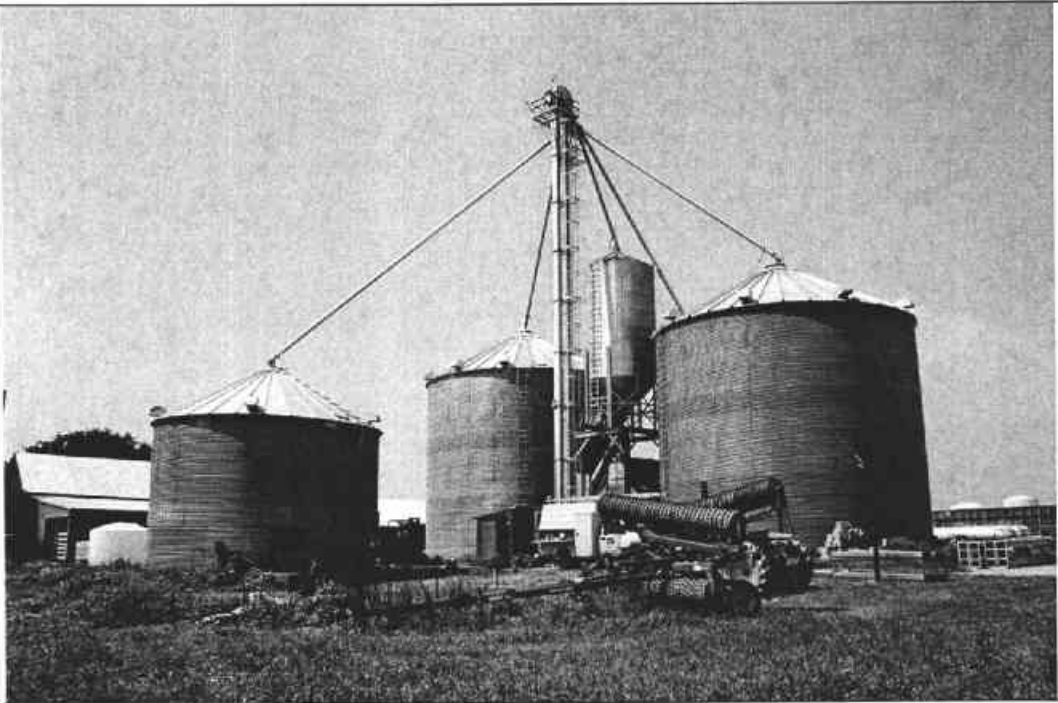
N05224. Photograph 5: Grain drying bins, view looking northeast.

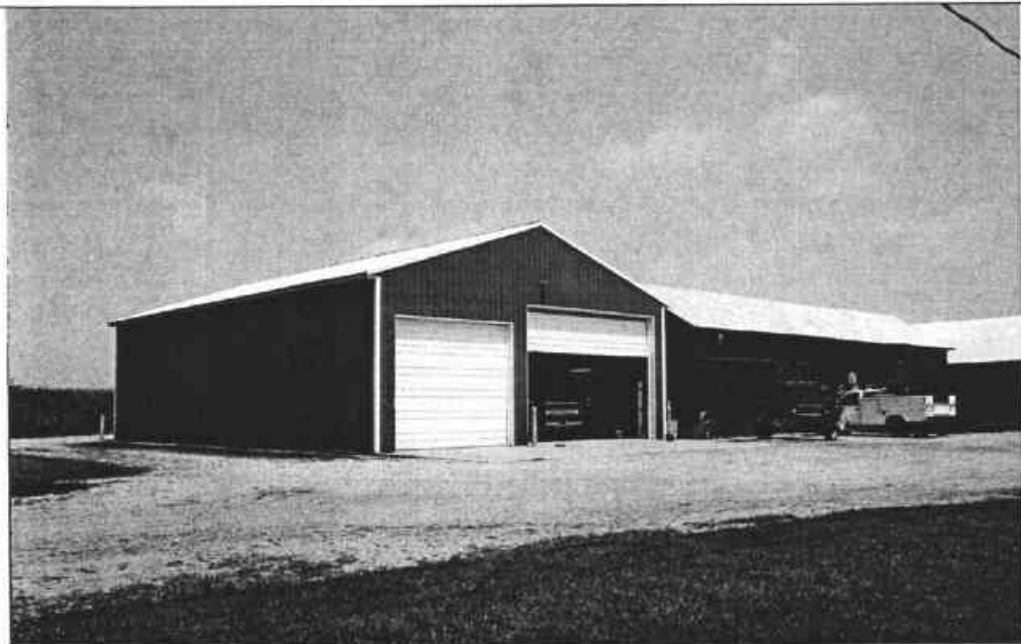
N05224. Photograph 6: Shop/machine shed, west and south elevations, view looking northeast. Note use of corncrib/granary doors at south elevation of central block.
